# Manhole Inspection Summary

Manhole # S47II\_050MH

Insp Date: **5/1/08 9:06 AM**

**Location** Address: **Montford Ave**

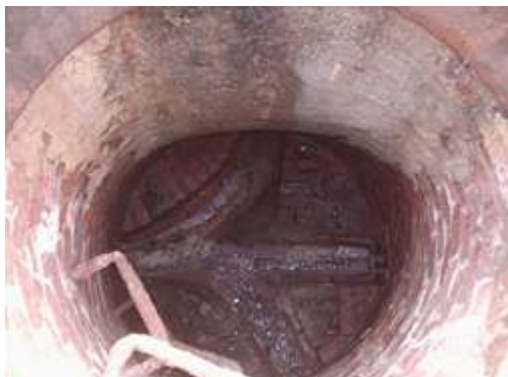
Defect 1

Infiltration: ☐ None ☒ **Joint** ☐ Cracks ☐ Mortar ☐ Roots ☐ Wall

Infiltration: ☐ None ☐ Joint ☐ Cracks ☐ Mortar ☐ Roots ☒ **Wall**

Infiltration

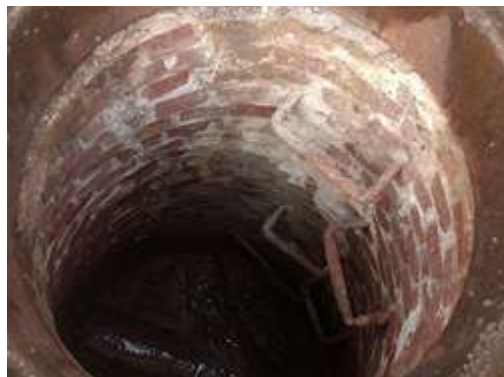
Defect 2

**Frame** Offset: **1** (in.) Condition: ☐ Sound ☐ Cracked ☒ **Leaks**

Frame Leaks

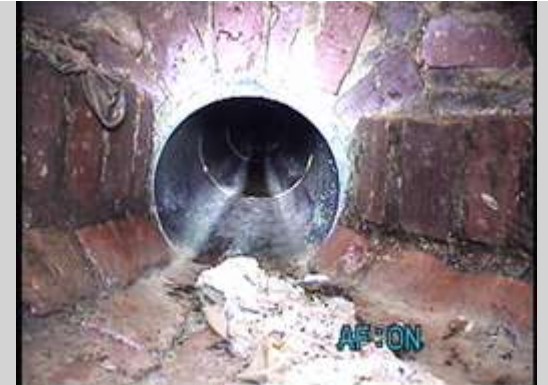
12 O'Clock Outflow

8 in. Circular Gravity Sewer  
Pipe Out @ 12 O'Clock

Pipe Height: **8.4** (in.) Rod and Bar (Angled)  
Pipe Material: **Clay** ☐ Pipe Lined  
Invert Depth: **8.80** (ft.) Flow Characteristics: **Slow**  
Deposits: ☒ None ☐ Mud ☐ Sludge ☐ Debris ☐ Grease  
Silt Depth: (in.) Deposits Extent:  
Infiltration: **None** Pipe Seal Cond: **Sound**

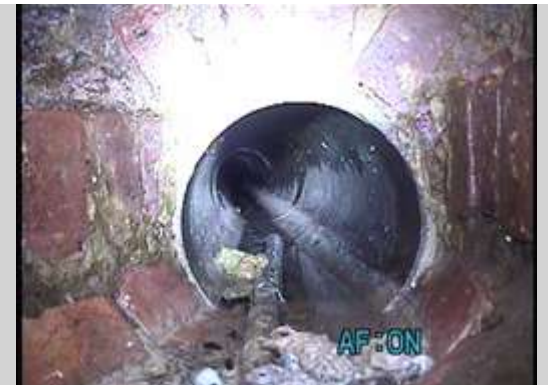
3 O'Clock Inflow

8 in. Circular Gravity Sewer  
Pipe In @ 3 O'Clock

Pipe Height: **8.4** (in.) Rod and Bar (Angled)  
Pipe Material: **Clay** ☐ Pipe Lined  
Invert Depth: **8.60** (ft.) Flow Characteristics: **Slow**  
Deposits: ☒ None ☐ Mud ☐ Sludge ☐ Debris ☐ Grease  
Silt Depth: (in.) Deposits Extent:  
Infiltration: **None** Pipe Seal Cond: **Sound**

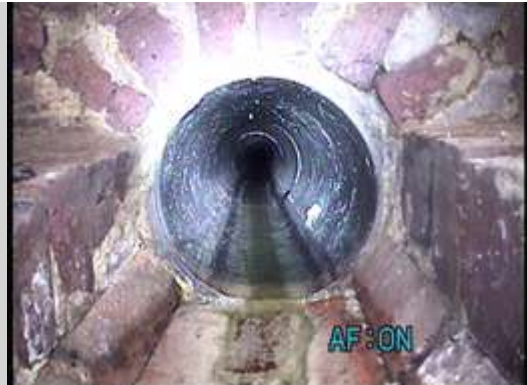
6 O'Clock Inflow

8 in. Circular Gravity Sewer

Pipe In @ 6 O'Clock

Deposits: ☒ None ☐ **Mud** ☐ Sludge ☐ Debris ☐ Grease

Infiltration: **None** Pipe Seal Cond: **Sound**

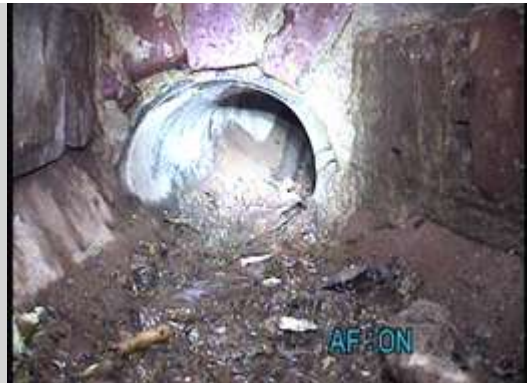
8 O'Clock Inflow

6 in. Circular Gravity Sewer

Pipe In @ 8 O'Clock

Deposits: ☐ None ☒ **Mud** ☐ Sludge ☐ Debris ☐ Grease

Silt Depth: **1** (in.) Deposits Extent: **Light**
